Manhole Inspection Summary

Manhole # S31EE2001MH

Insp Date: **11/30/06 11:13 AM**

Location Address: **5700 SAINT ALBANS WAY**

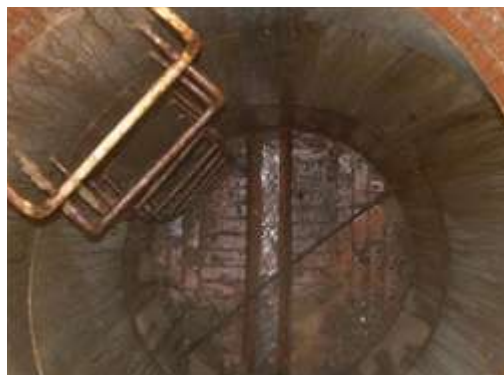
Top View

☒ **Debris** (not Condition related)

Bench debris.

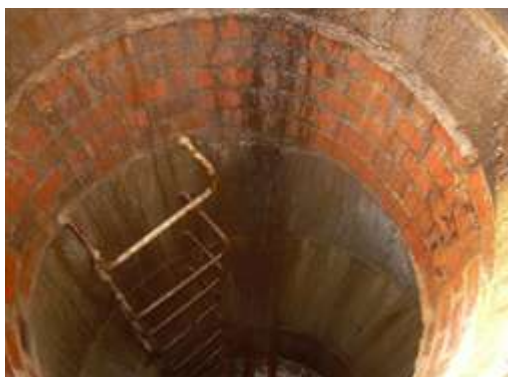
Defect

Infiltration: ☐ None ☒ **Joint** ☐ Cracks ☒ **Mortar** ☐ Roots ☒ **Wall**

Infiltration: ☐ None ☒ **Joint** ☐ Cracks ☐ Mortar ☐ Roots ☐ Wall

Adjustment and Corbel infiltration - other side.

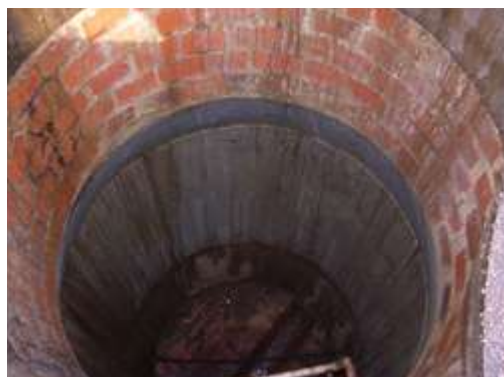
Defect

Infiltration: ☐ None ☒ **Joint** ☐ Cracks ☐ Mortar ☐ Roots ☐ Wall

Adjustment, Corbel and Barrel infiltration.

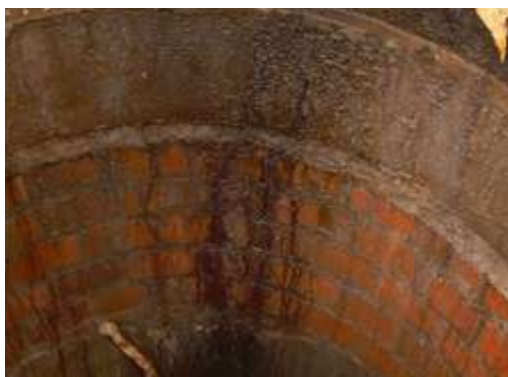
Defect

☒ **Leaks**

Frame leaks. Adjustment infiltration.

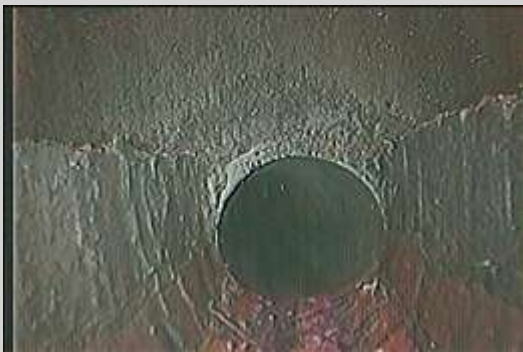
8 in. Circular Gravity Sewer Pipe Out @ 12 O'Clock

Infiltration: **Evidence** Pipe Seal Cond: **Cracked**

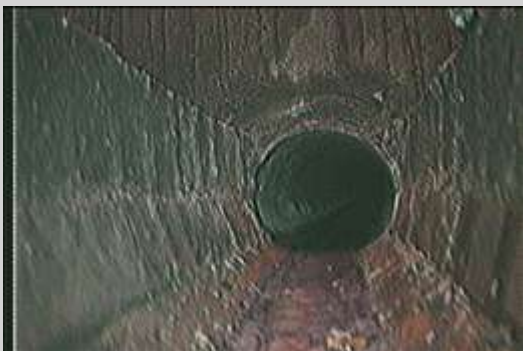
8 in. Circular Gravity Sewer Pipe In @ 6 O'Clock

Condition: ☐ Sound ☐ Cracked ☐ Root Intrusion ☒ **Deteriorated** ☐ Leaks ☐ Debris

Channel deterioration.

Deposits: ☐ None ☐ Mud ☐ Sludge ☐ Debris ☒ Grease

Silt Depth: **0** (in.) Deposits Extent: **Light**
